**Project: Almásfüzitő, Hungary**

(gas engine with 3 MW<sub>e</sub>, 3 MW<sub>th</sub> installed capacity)

**Used material: PSC**

**Place of use: Hot water Pipeline system**

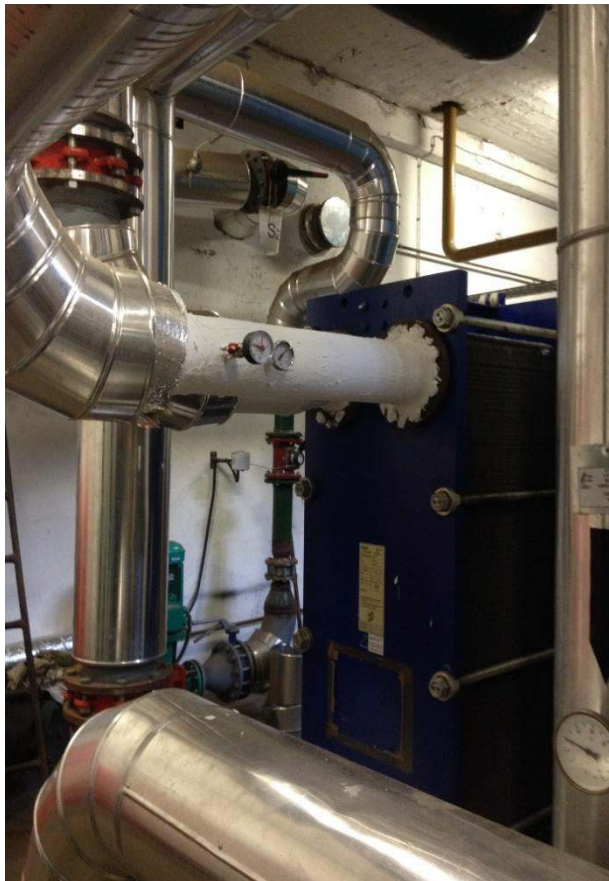
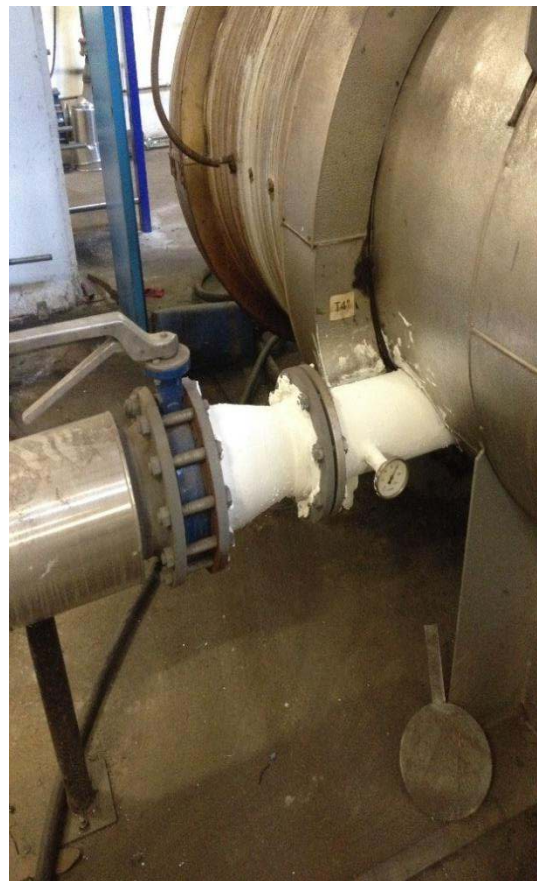
The rockwool insulation and the tin coating are very complicated to use on a surface with many outstanding pipes, or measuring points. That's why we have used PSC. Painted it by a paintbrush 3 layers.

Some picture of the place of use:

We have installed some thermal and pressure measuring instruments into the heating pipeline system before and after the heat exchangers at our CHP unit Almásfüzitő. 135 m<sup>3</sup> 80°C-85°C hot water circling in the heating-pipeline system per hour. When we built the heat and pressure measures into the system, we had to remove the rockwool insulation and the tin coating.

One of the most important things is to minimize the heat loss until the selling point. To reach this goal, we had to insulate the holes on the pipeline system.

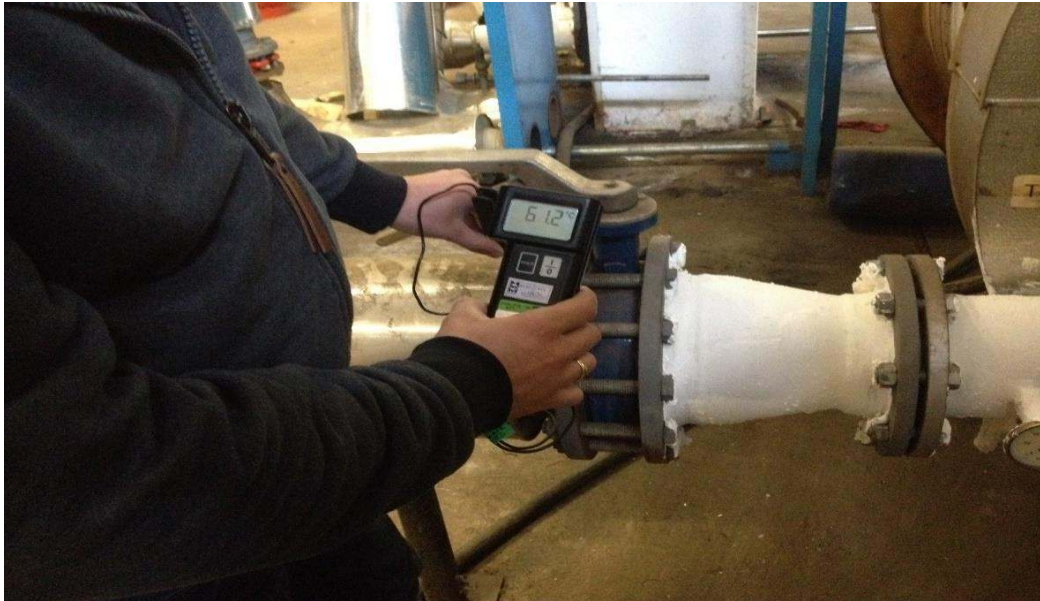
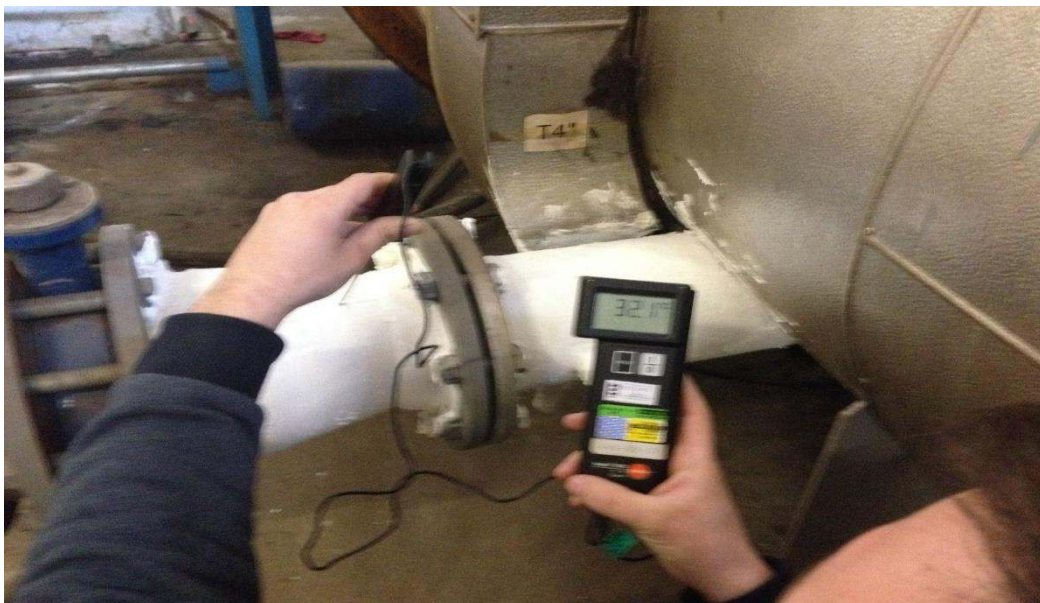
After the painting was dry, we checked the temperature of the surfaces, seen on pictures below:

Temperature was measured with a certified touch thermometer. During the measurement the hot water in the pipeline system was: 80°C.

| Temperature of the surface of the pipeline system, without PSC insulation: | 61,2 °C |
| Temperature of the surface of the pipeline system, with PSC insulation: | 32,2 °C |

As it is shown above, the temperature of the surface we used PSC reduced almost 30 °C. It is considered as a great result. Our experiences with the PSC were: easy to apply, it dries fast on hot surface, usable at any surface, heat insulation factor is high, water resistant, easy to correct if damaged.
